**HOOPER BAY AIRPORT  
IMPROVEMENTS**

**PROJECT No. 57419**

**RECONNAISSANCE STUDY, 2005**

**STATE OF ALASKA  
DEPARTMENT OF TRANSPORTATION  
AND PUBLIC FACILITIES**

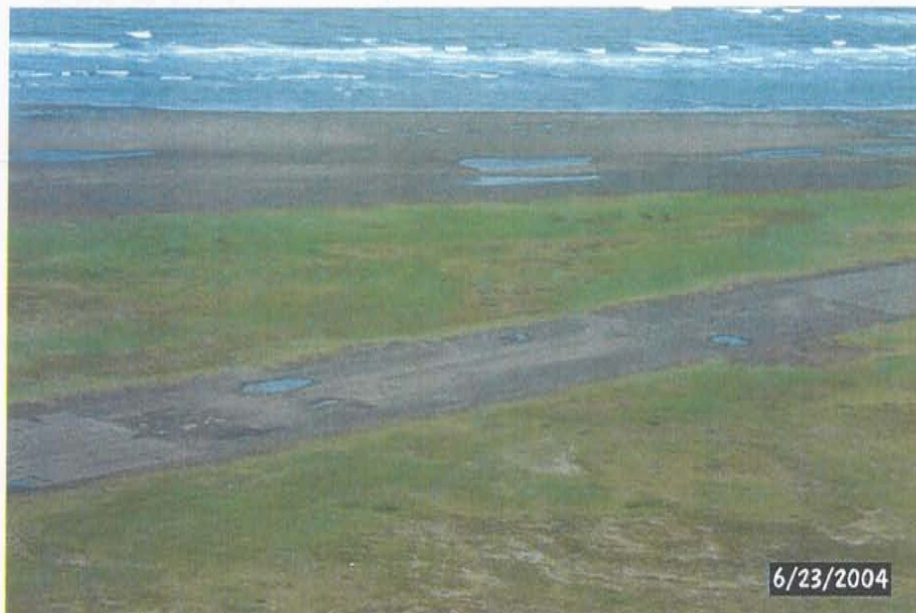
The existing airport facilities have a limited life expectancy due to beach erosion, inland flooding and other mitigating factors. Because of these immediate concerns, an interim project is required before a long-term solution can be implemented. It is recommended that an interim project include a surface treatment for approximately 570' of asphalt pavement missing from the center section of the runway (as shown right).

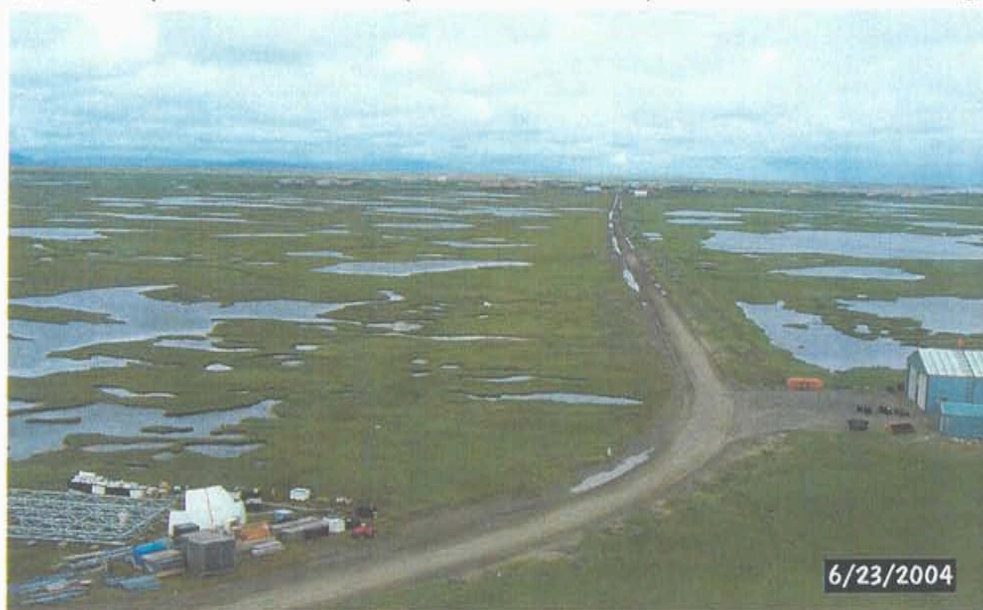
In addition to the runway surfacing, an interim project should also include a stabilized base for the airport access road (as shown below) to withstand recurring flood events. The

airport access road is presently in poor condition and is subject to recurring flood events. The road elevation is approximately 1.5' to 3.5' above mean sea level, while the airport is located on coastal dunes adjacent to the Bering Sea at a higher elevation of approximately

9'. According to locals, the area can be inundated with up to four feet of standing water. In addition to the flooding, the access road also experiences significant wear from

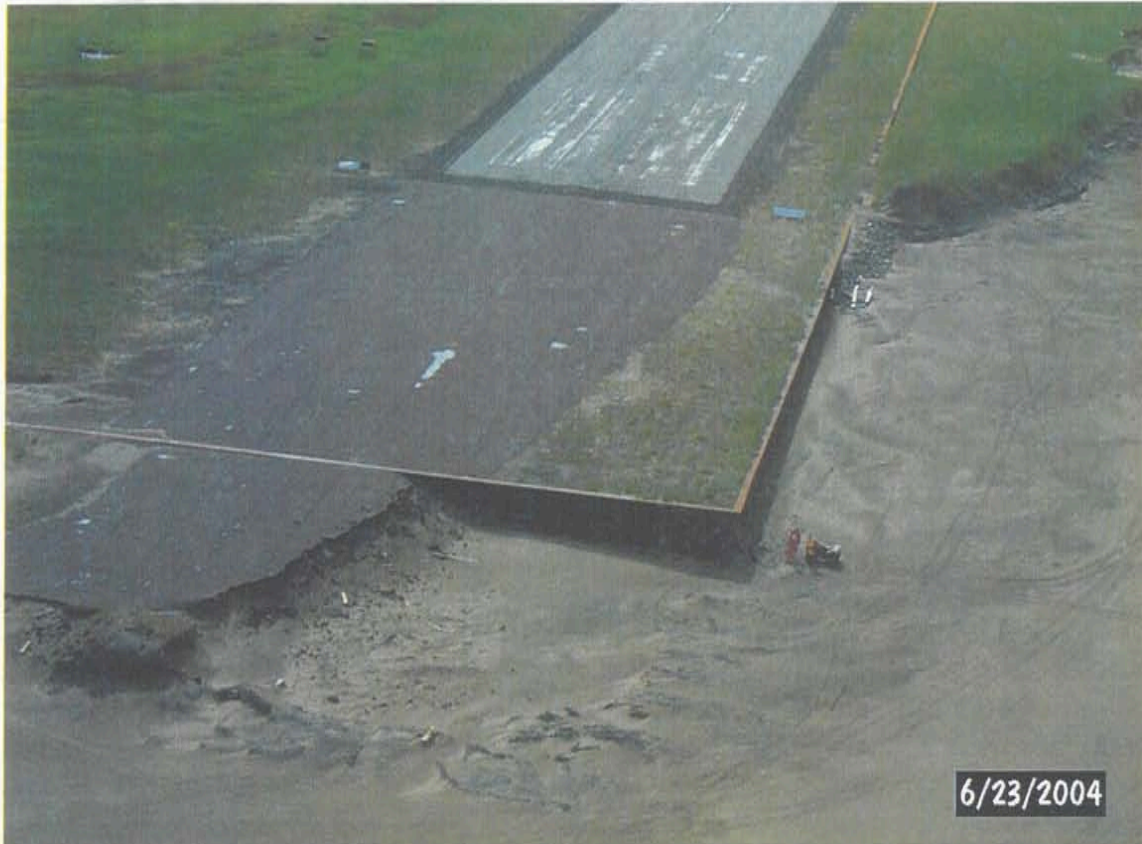
Runway erosion is not as much of an immediate concern as the runway surfacing or the stabilization of the access road, but it is a major factor when considering the remaining useful life of the existing facility. The picture shown below depicts the end of the existing

runway (13). Prior to 1996, the pavement was eroding at an accelerated rate so sheet piling was installed in an attempt to maintain the existing embankment. This photo also shows the ongoing undermining of the surface course located outside the piling. At the apparent erosion rate of 8-feet per year, it is estimated that the erosion will breach the ends of the sheet pile wall in another 7 to 10 years. This timeline limits the design life of the existing facilities and warrants a long-term solution. A cost estimate has been prepared for an interim project as described and is located in Appendix V.

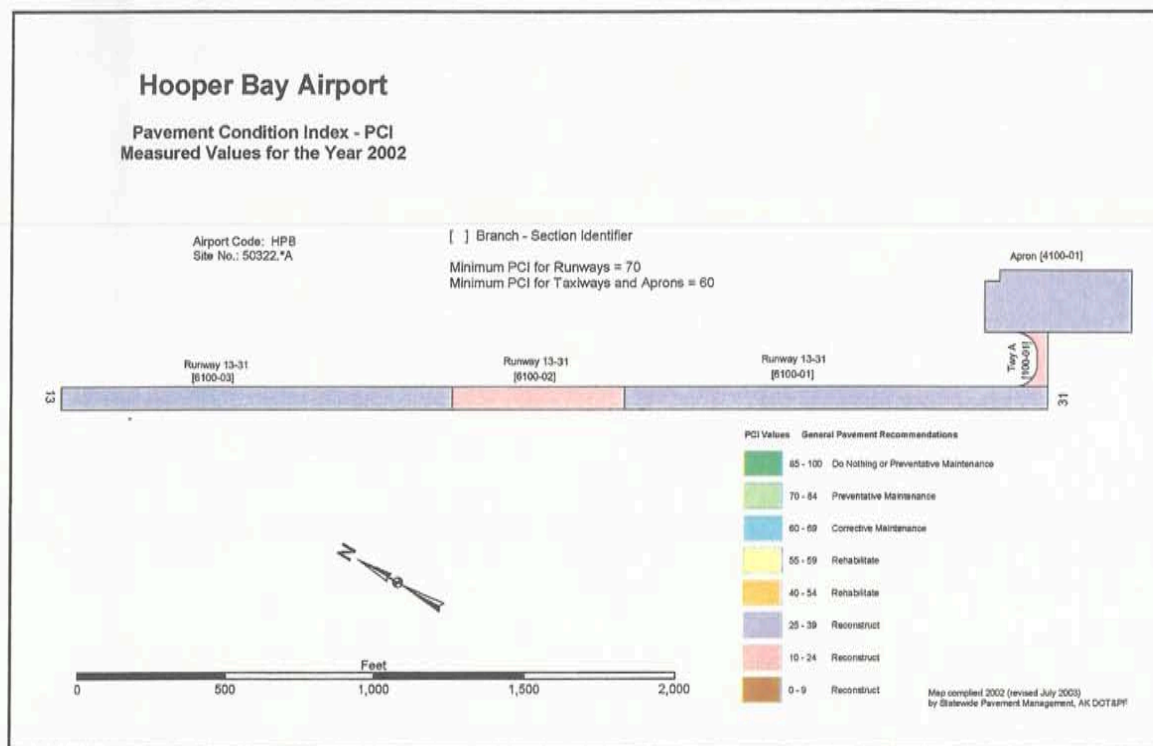
The runway, taxiway and apron were evaluated in 2002 using the Corps of Engineers Pavement Condition Index (PCI). The graphic shown on the next page summarizes the evaluation.

A perfect, new pavement has a PCI value of 100. Deductions are made for measured pavement distresses so that a completely failed pavement would have a PCI of 0. As indicated in the 2003 PCI report, the average weighted runway PCI for Hooper Bay was 31, while the taxiway and apron scored a 28. As previously shown, all existing pavement falls under the "reconstruct" category.

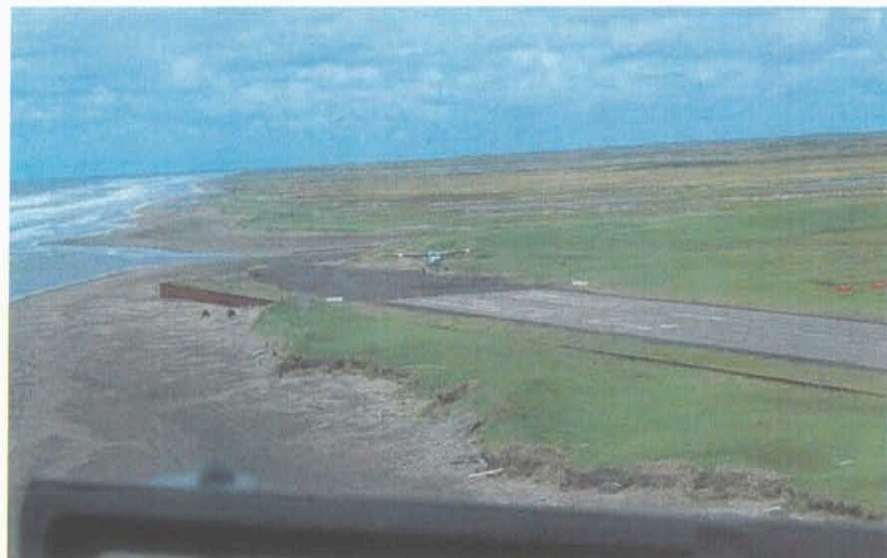
In 1996, the department installed 1000 feet of sheet pile along the north end of the runway (as shown right). Originally designed as a "last defense" to erosion, modifications to the original sheet pile plan moved the wall into a more active wave environment. Because of the design change, the ArmorFlex anchor system was cut after the installation of the

sheet pile and the blocks were left in place to provide scour protection at the toe of the wall. At the time it was thought that these erosion measures would extend the life of the runway as much as 20 years. However, erosion rates at that time were approximated at 3 feet per year. With current approximations at 8 feet per year, it may be necessary to relocate the runway in the near term.

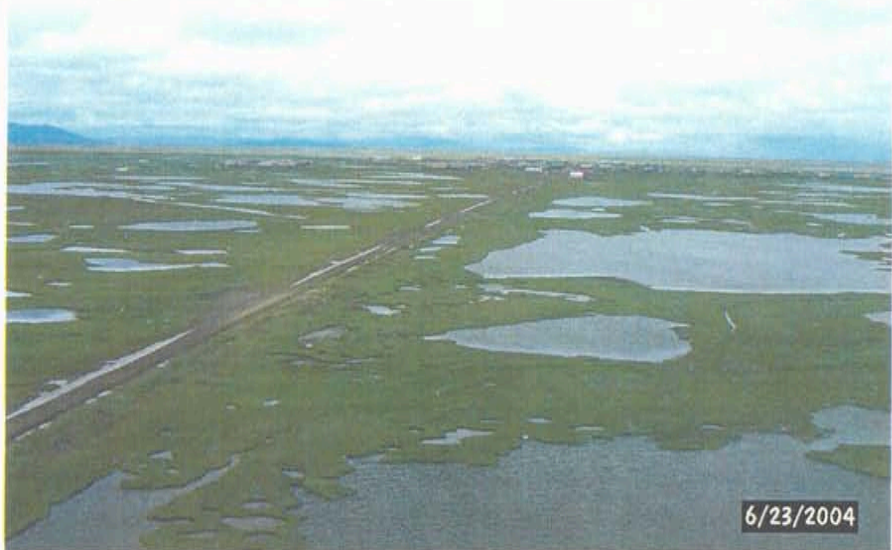
Another immediate concern is the airport access road. The existing road is in use, but is in major need of repair. As shown below, flooding and storm surge events have eroded nearly all of the useable

material from the road, which currently exists as a footprint, with sections falling below the surrounding terrain. Because of these high water events, the interim design prohibits the possibility of building up the road without major erosion protection. For an interim project, this would prove quite costly to construct and difficult to maintain. Because of these concerns it is

recommended that the interim project place 1.5' of medium sized aggregate (3" – 8") to provide a shallow solid base that will be resistant to flooding erosion. The low profile will still allow high water events to pass over the road, but will remain in place after the event.

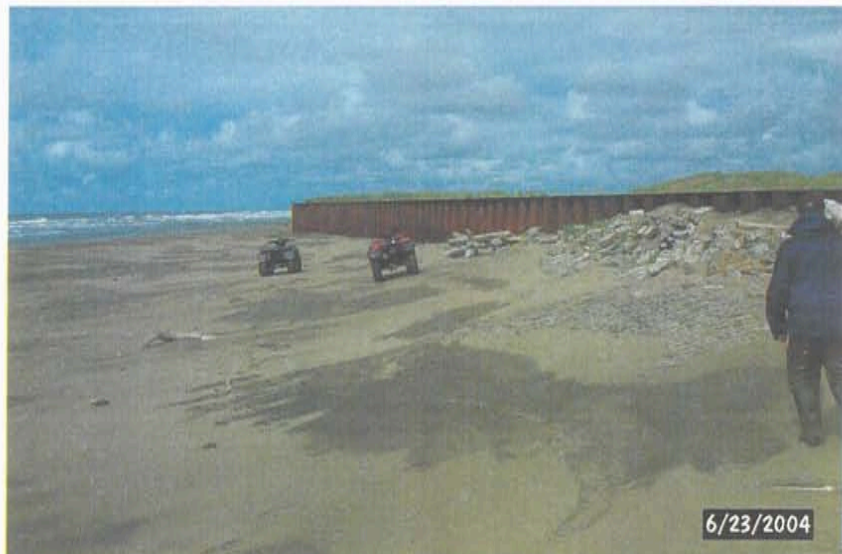
The Department's Coastal Engineering Section was consulted and with the apparent erosion rate of 8-feet per year, erosion will have breached the ends of the sheet pile wall in another 7 to 10 years. The picture to the right depicts the sheet pile wall and some of the concrete

matting installed during a 1996 project to prevent or slow down the rate of erosion. If erosion slows to the rate of 3 feet per year (historical rate observed from 1951 to 1994), the design life could possibly be extended to 30 years. Using either rate, erosion will prohibit a 50-year design life if the existing airport is reconstructed.

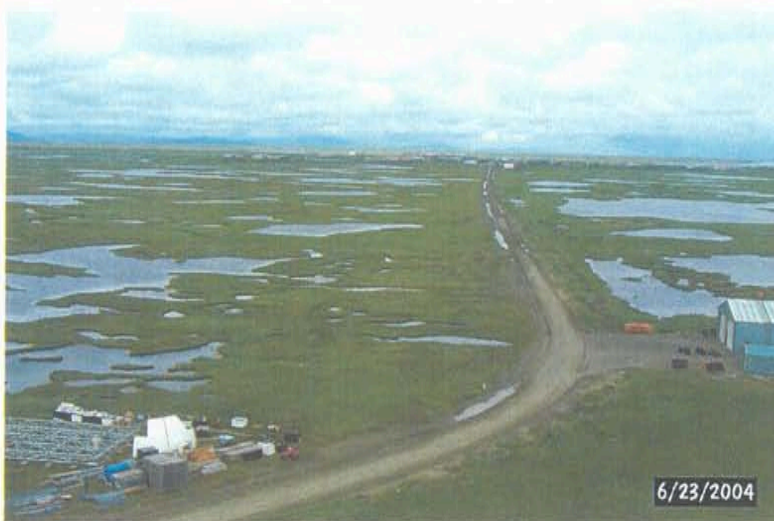
An obvious debris line composed of logs and abandoned vessels is visible at the toe of the numerous small hills north of Hooper Bay. This indicates the extent of flooding from storm surge events. During a field trip conducted on June 23, 2004, locals commented that the existing airport access road (as shown right) is subject to flooding from these events, which inundate the area with up to four feet of standing water. It was also learned that flooding occurs at least every two years to the extent that the road is impassible from the edge of the city to the airport. However, there is no evidence indicating that the village or airport has ever flooded. (Note: the elevation of Hooper Bay City is 35' on a USGS quad map, datum WGS84/NAD83.)

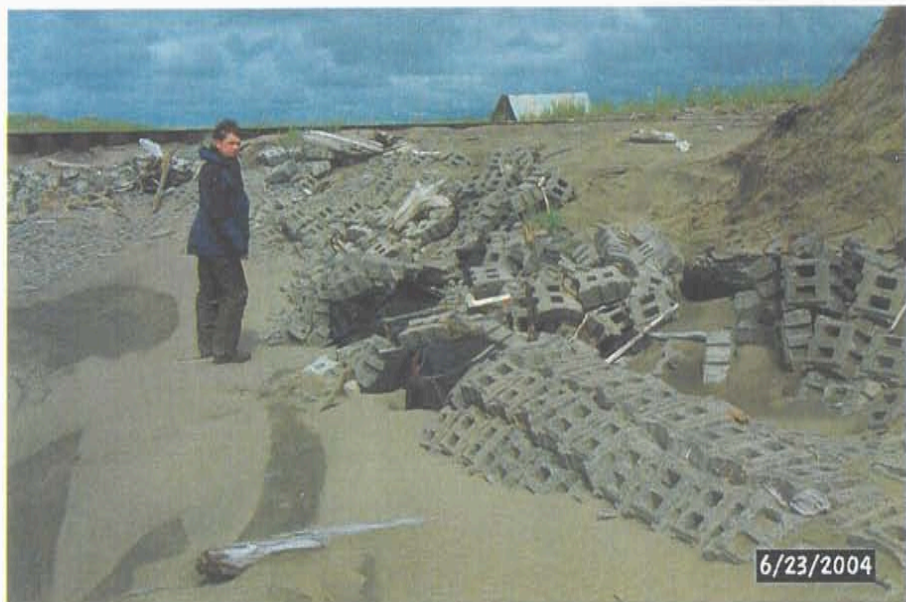
In addition to storm surge events and its related flooding, the existing airport is subject to beach erosion as shown right. The airport is located on coastal dunes adjacent to the Bering Sea, which has fetches hundreds of miles in length. Waves on the Bering Sea shelf exceed 30-feet. As the waves near the coast, they shoal and break

on the offshore bars. Generally, by the time they reach the beach, the waves are parallel to the shoreline and offshore bars. These waves impact the beach causing sedimentary transport. Although the sedimentary transport is bi-directional, the dominant direction is to the south. This means that the northern end of the runway will be subject to continued erosion. Presently, the northern end of the runway acts somewhat like a groin. The natural tendency of the beach would be to smooth the north end of the runway to conform to a more natural beach line.

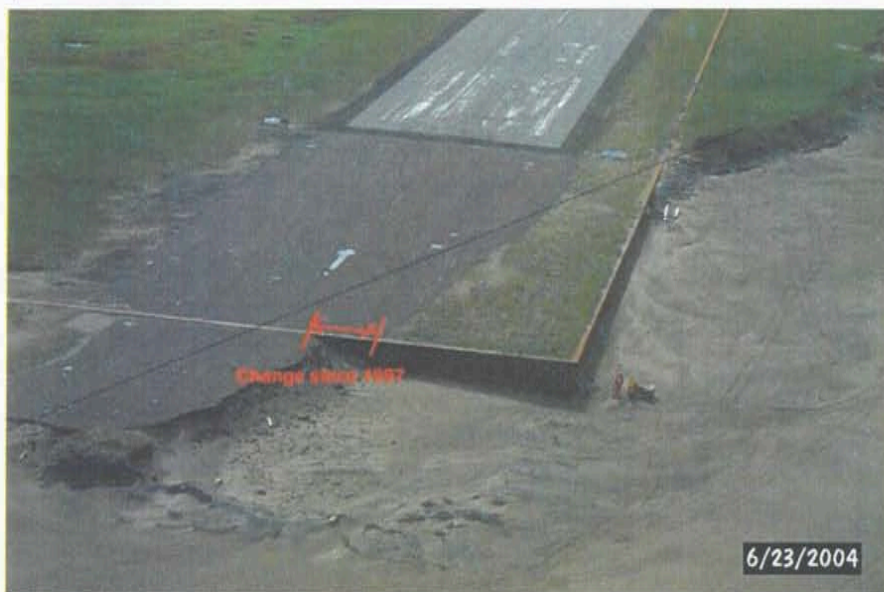
However, looking at a more recent 1997 photograph (shown right) and comparing it with a print from 1968, the beach has receded over 200-feet or about 8 feet per year. Changes in the rate of erosion can be due a number of issues such as the reduced sea ice, influence of the sheet pile wall acting as a groin, additional beach mining, larger storms, melting permafrost, global warming and sea level rise.

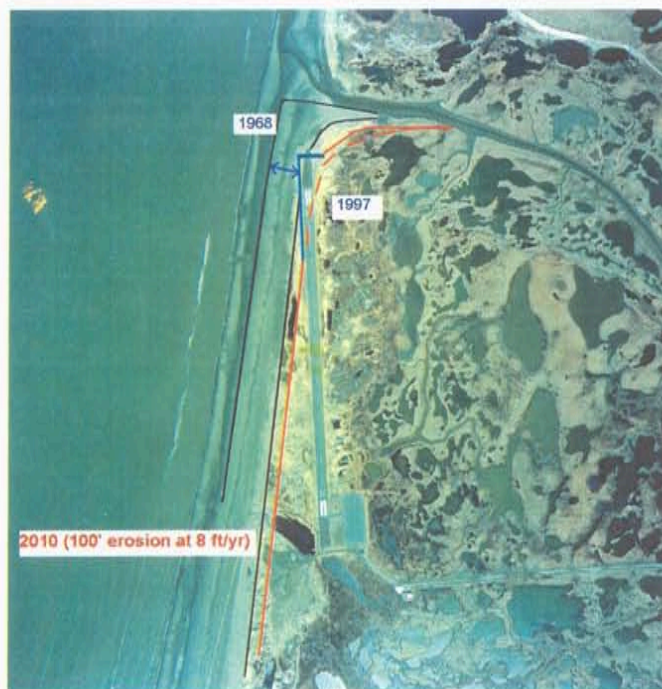
At the apparent erosion rate of 8-feet per year, erosion will have breached the ends of the sheet pile wall in another 7 to 10 years. This is depicted in the graphic shown right. The red line depicts what the beach line would be at the erosion rate of 8 feet/year. If erosion slows to the previous rate of 3 feet per year, we are looking at about 30 years. Either way, this does not provide a 50-year life.

In the event that the airport is reconstructed at its present location, erosion would affect the northwest corner of the safety area within 10 years (if the sheet pile were not in place). To

provide a 50-year design life at its present location, a 400-foot buffer measured perpendicular to the beach and between the edge of the vegetated berm and the northwest corner of the proposed reconstructed runway section would be needed, assuming 8 feet of erosion per year. This would place the northwest corner of the safety area about 2,400 feet south of the sheet pile corner along the current alignment.

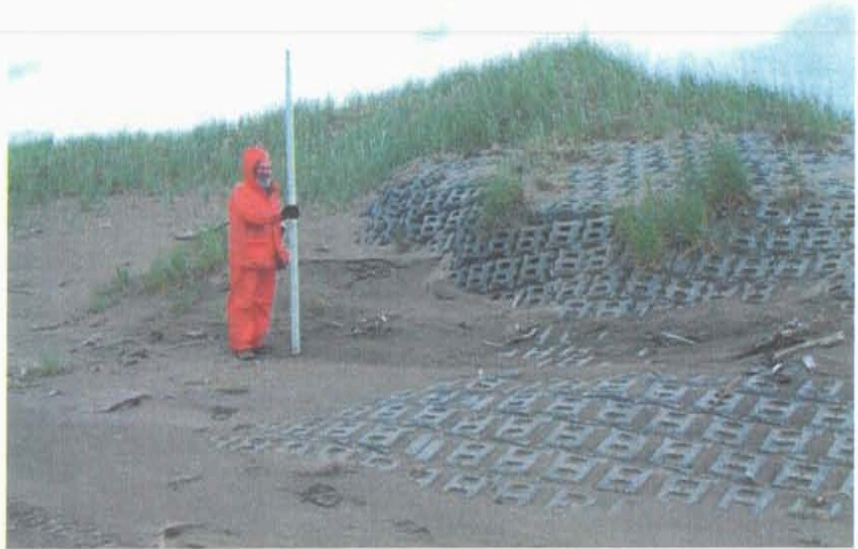
As mentioned in the Airport Project History section, an ArmorFlex concrete block system was constructed in 1981 to protect the bank from erosion. The ArmorFlex placed at Station 22+00 (as shown right) is stable and remains in good condition on a 3 to 1 slope. There is wild beach rye growing around the concrete armor units, which helps promote stability. However, areas with steep, non-vegetated bluffs between sections with ArmorFlex are actively eroding.

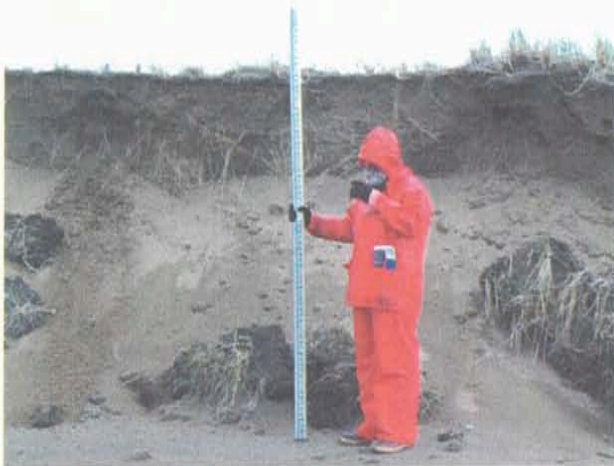
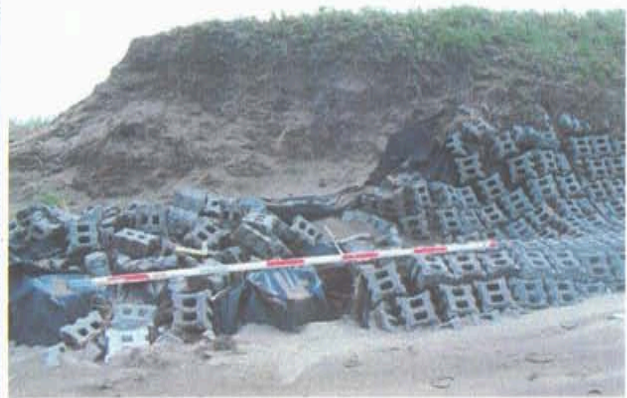
As you approach the north end of the runway, the beach slopes are less stable and erosion is evident (depicted below). The ArmorFlex mat on the north end of the runway is in a failed condition, but is still effective in stabilizing the shoreline. Barrels from the earlier project are visible under the debris as shown in the picture below.

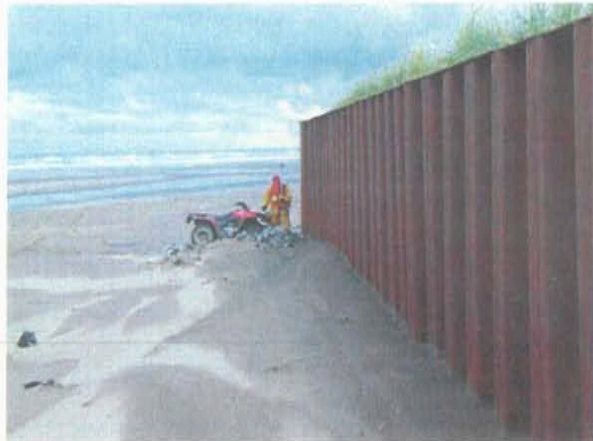
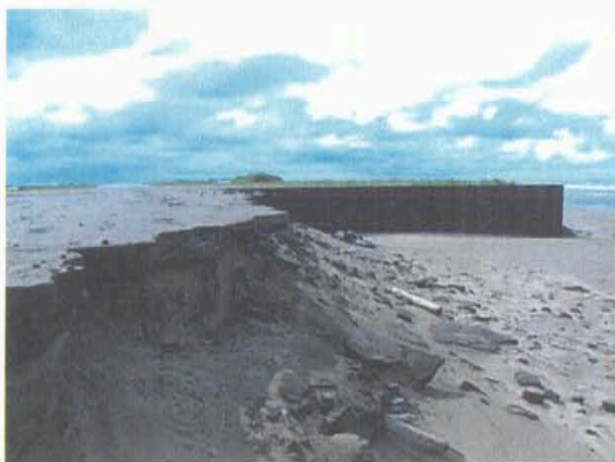
The sheet pile wall (shown right) at the north end of the runway is in relatively good condition, with little rust present. The east-west portion of the wall appears to adequately protect the runway from the stream located just beyond the north end. However, active erosion from the Bering Sea is occurring on the beach side of the wall. Fifty percent of the wall height (about 10 feet) is visible on the north end of the runway. There is some evidence of toe scour, but no evidence of overtopping.

The remaining pavement, which extends beyond the sheet pile onto the beach, is overhanging (as shown left). The more densely packed sand beneath this asphalt is eroding more slowly than the surrounding bluff.

If the existing airport is reconstructed, it is recommended that either: (a) add slope stabilization to protect the sheet pile wall, or (b) ensure the sheet pile wall will be stable during the design scour event without slope stabilization.

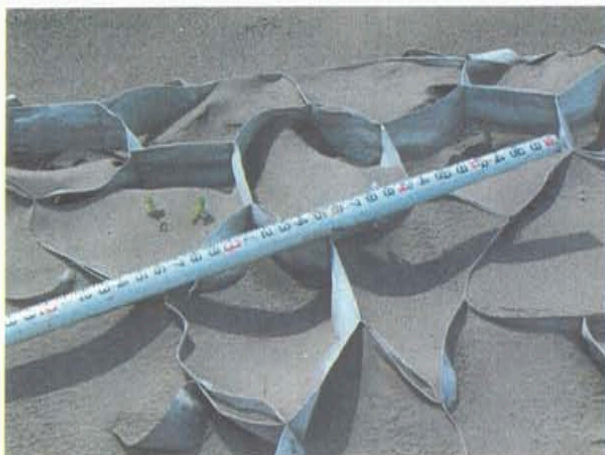
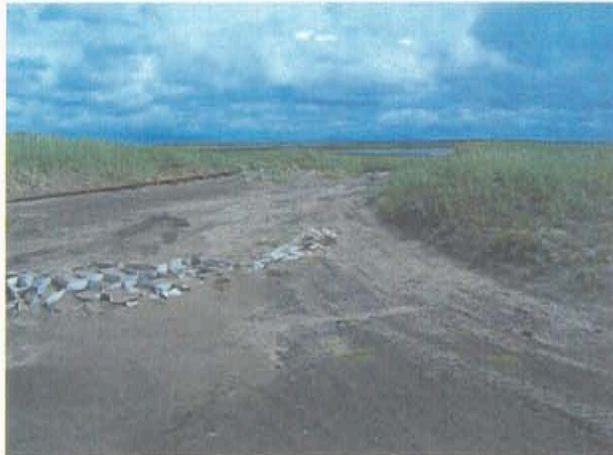
Seeding has proved to be an effective method of controlling erosion on flat ground. Most areas replanted with wild beach rye in 1996 are doing well. A geotextile grid was used to help stabilize the sand while the rye took hold (as shown below). The only unvegetated area is on the northeast end of the runway where four wheelers access the runway. In the photo below, it can be seen how the grasses have provided a solid vegetative cover in undisturbed areas.

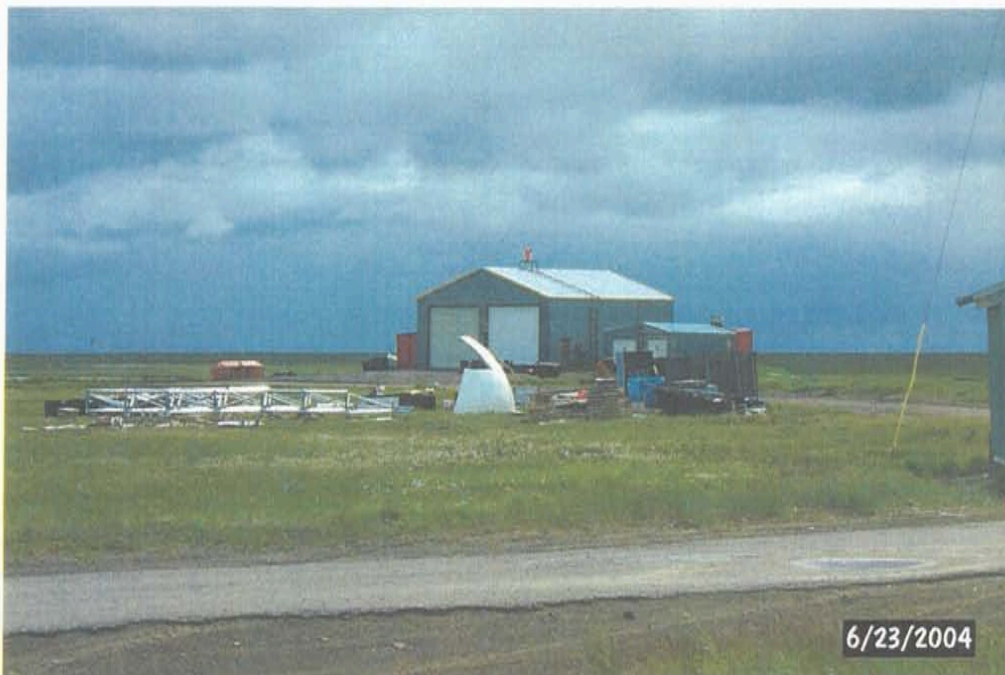
Hooper Bay currently has a 40' x 60' two-bay unheated snow removal equipment building, which is shown in the picture below. The building was built in 1964 and is currently included in the AIP spending plan for replacement. The plan includes a new heated 3-bay building with metal floor, which shall be located on the proposed apron.
